# Debris/Ice/TPS Assessment and Integrated Photographic Analysis for Shuttle Mission STS-54

(NASA-TM-107558) DEBRIS/ICE/TPS  
ASSESSMENT AND INTEGRATED  
PHOTOGRAPHIC ANALYSIS FOR SHUTTLE  
MISSION STS-54 Final Report, 12-21  
Jan. 1993 (NASA) 146 p

DEBRIS/ICE/TPS ASSESSMENT  
AND  
PHOTOGRAPHIC ANALYSIS  
OF  
SHUTTLE MISSION STS-54

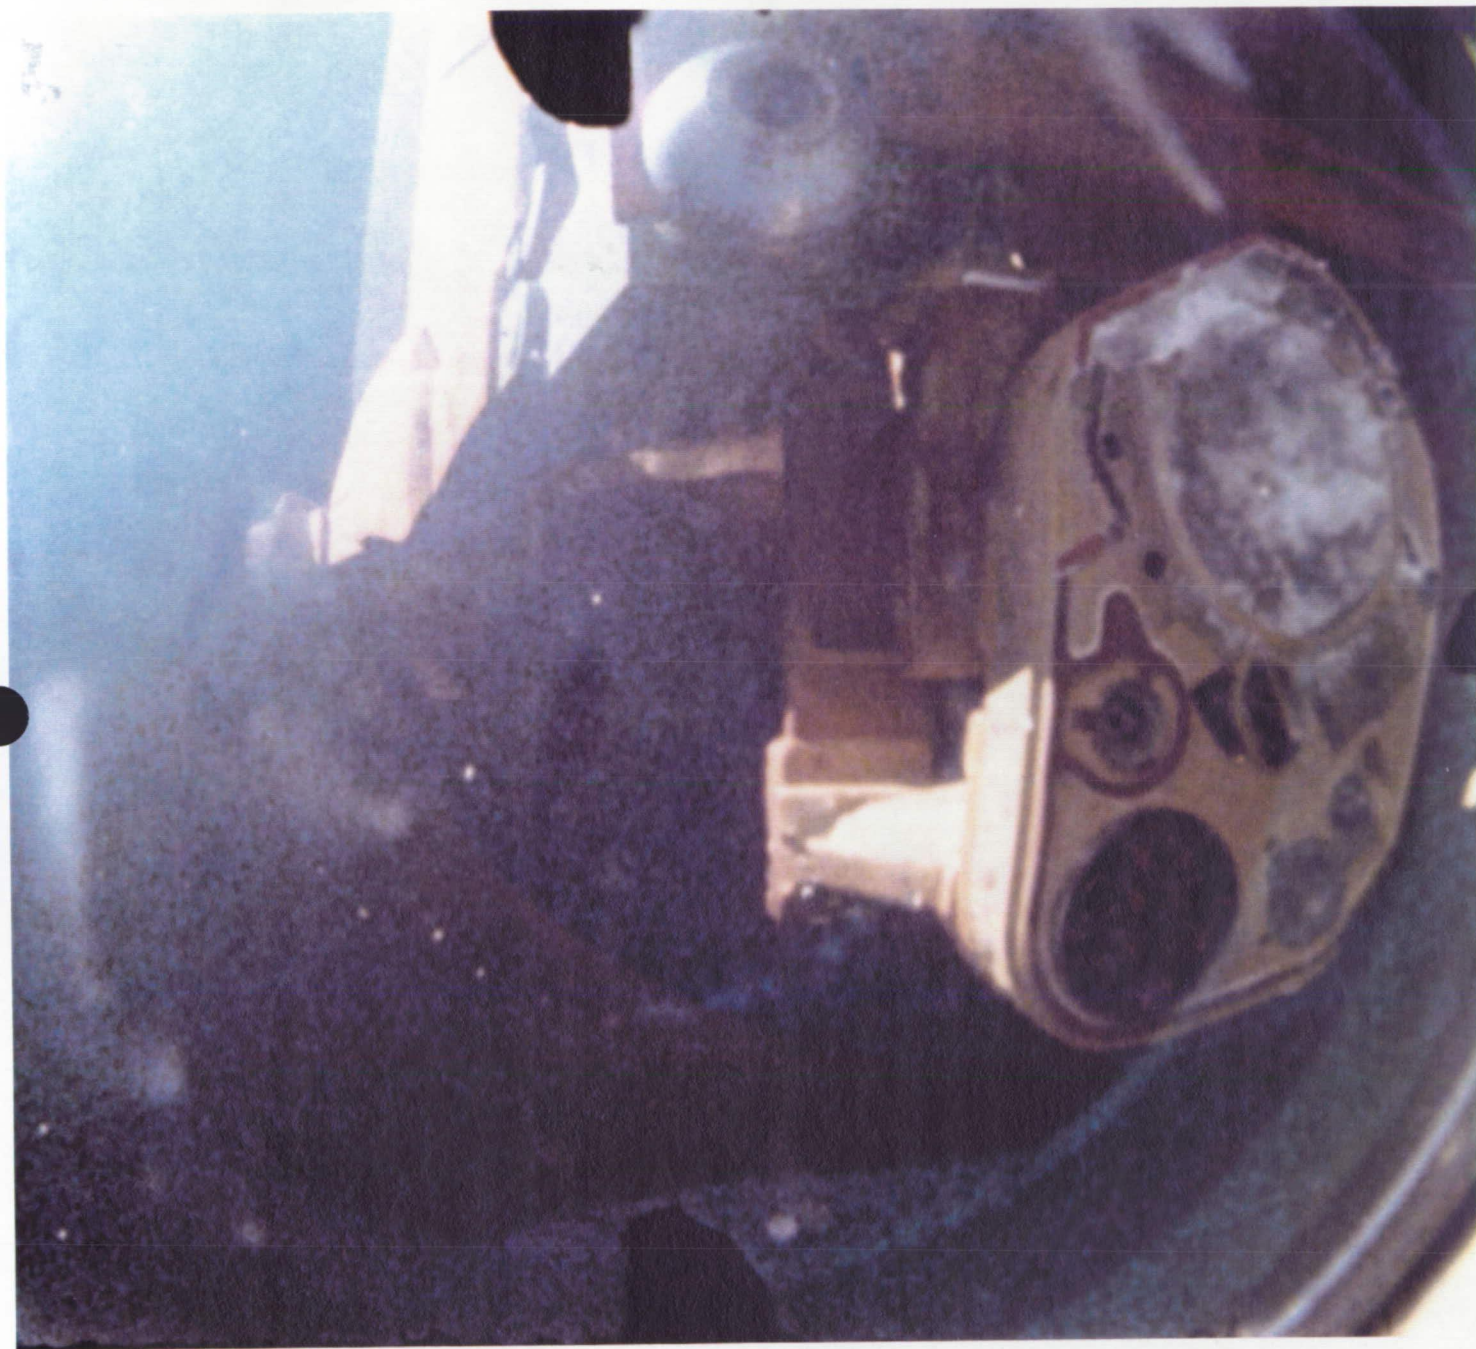
Frozen hydrogen, but no TPS or structural damage, was visible on the LH2 ET/ORB umbilical interface. Erosion and charring of TPS on the aft surfaces of the LH2 umbilical cable tray and the -Y vertical strut/cable tray was typical.

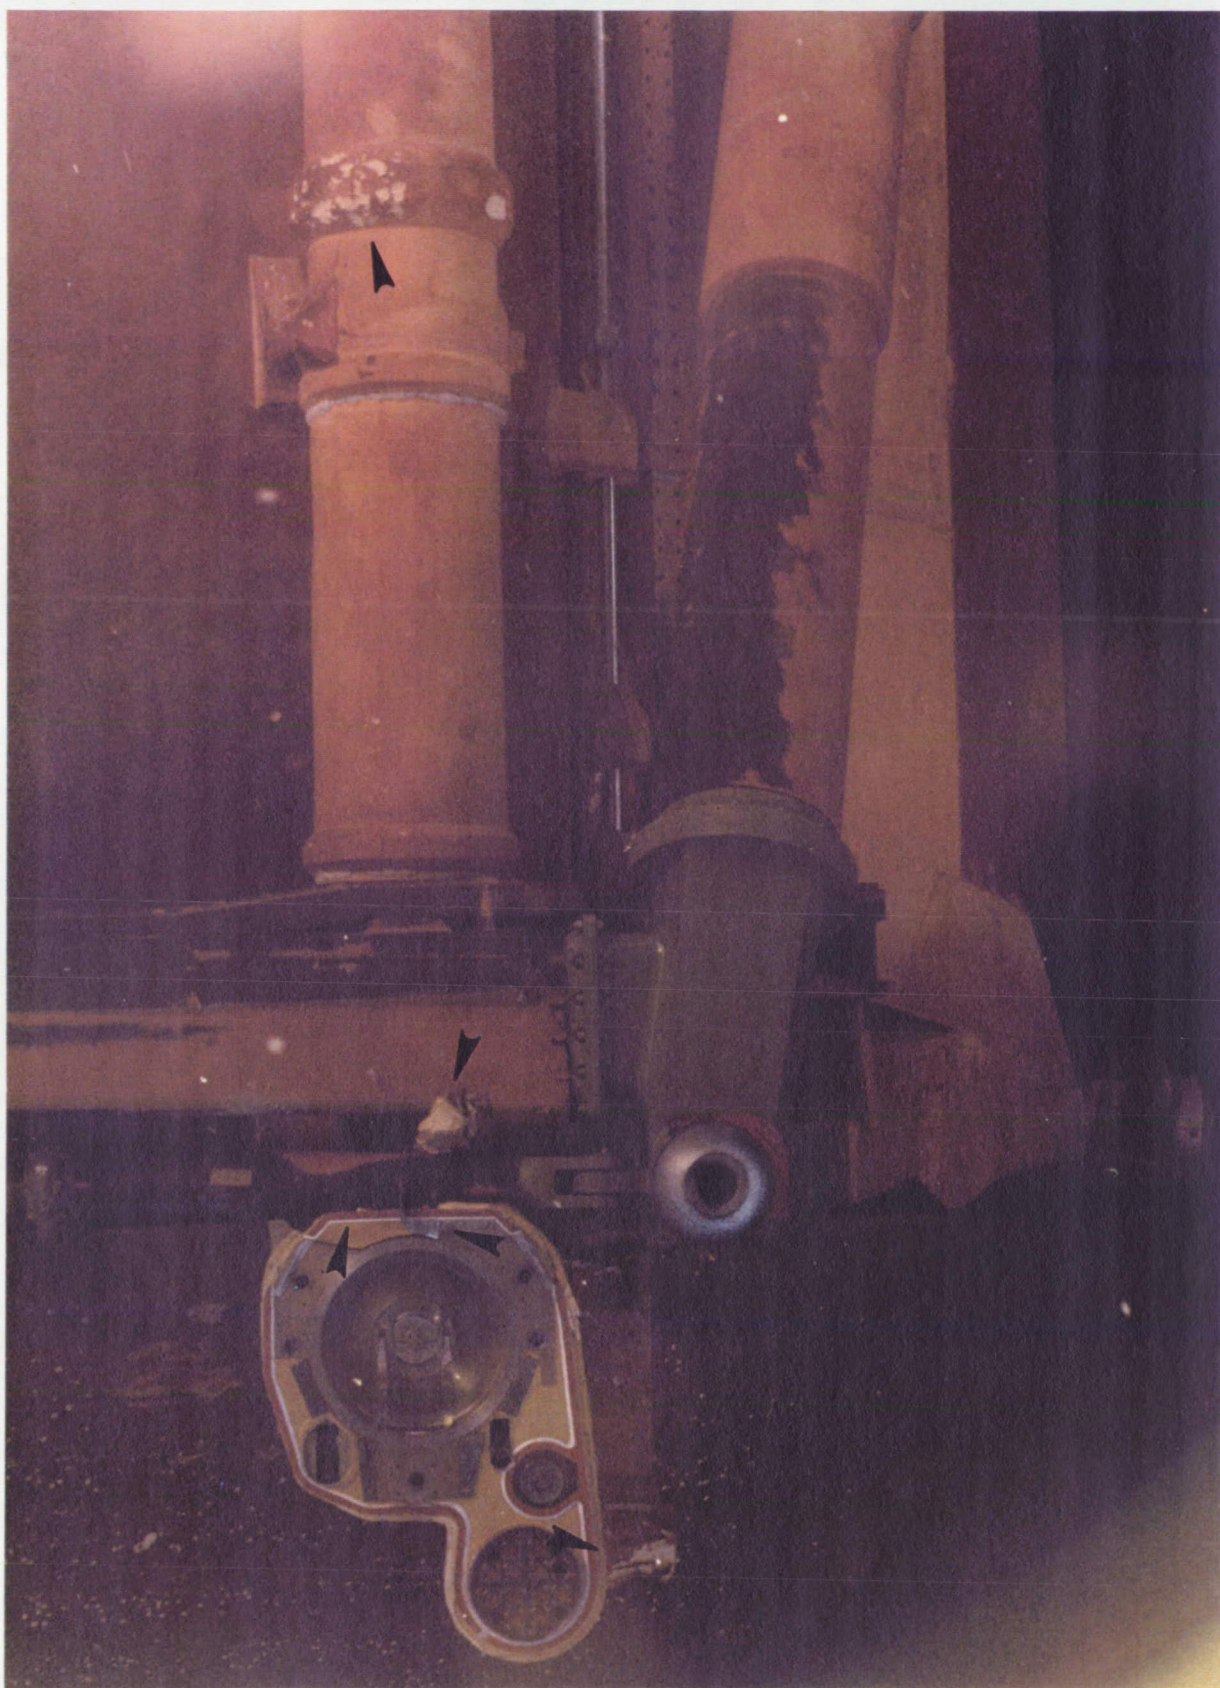
TPS damage was visible on the forward surface of the LO2 ET/ORB umbilical. A 6-8 inch diameter piece of foam wedged between the diagonal strut and the crossbeam may have originated from this area. Sixty percent of the lightning contact strip was debonded and bent in the forward direction. TPS was missing from the cable tray horizontal section and the underlying SLA was exposed. Some TPS had eroded from the LO2 feedline flange closeout.

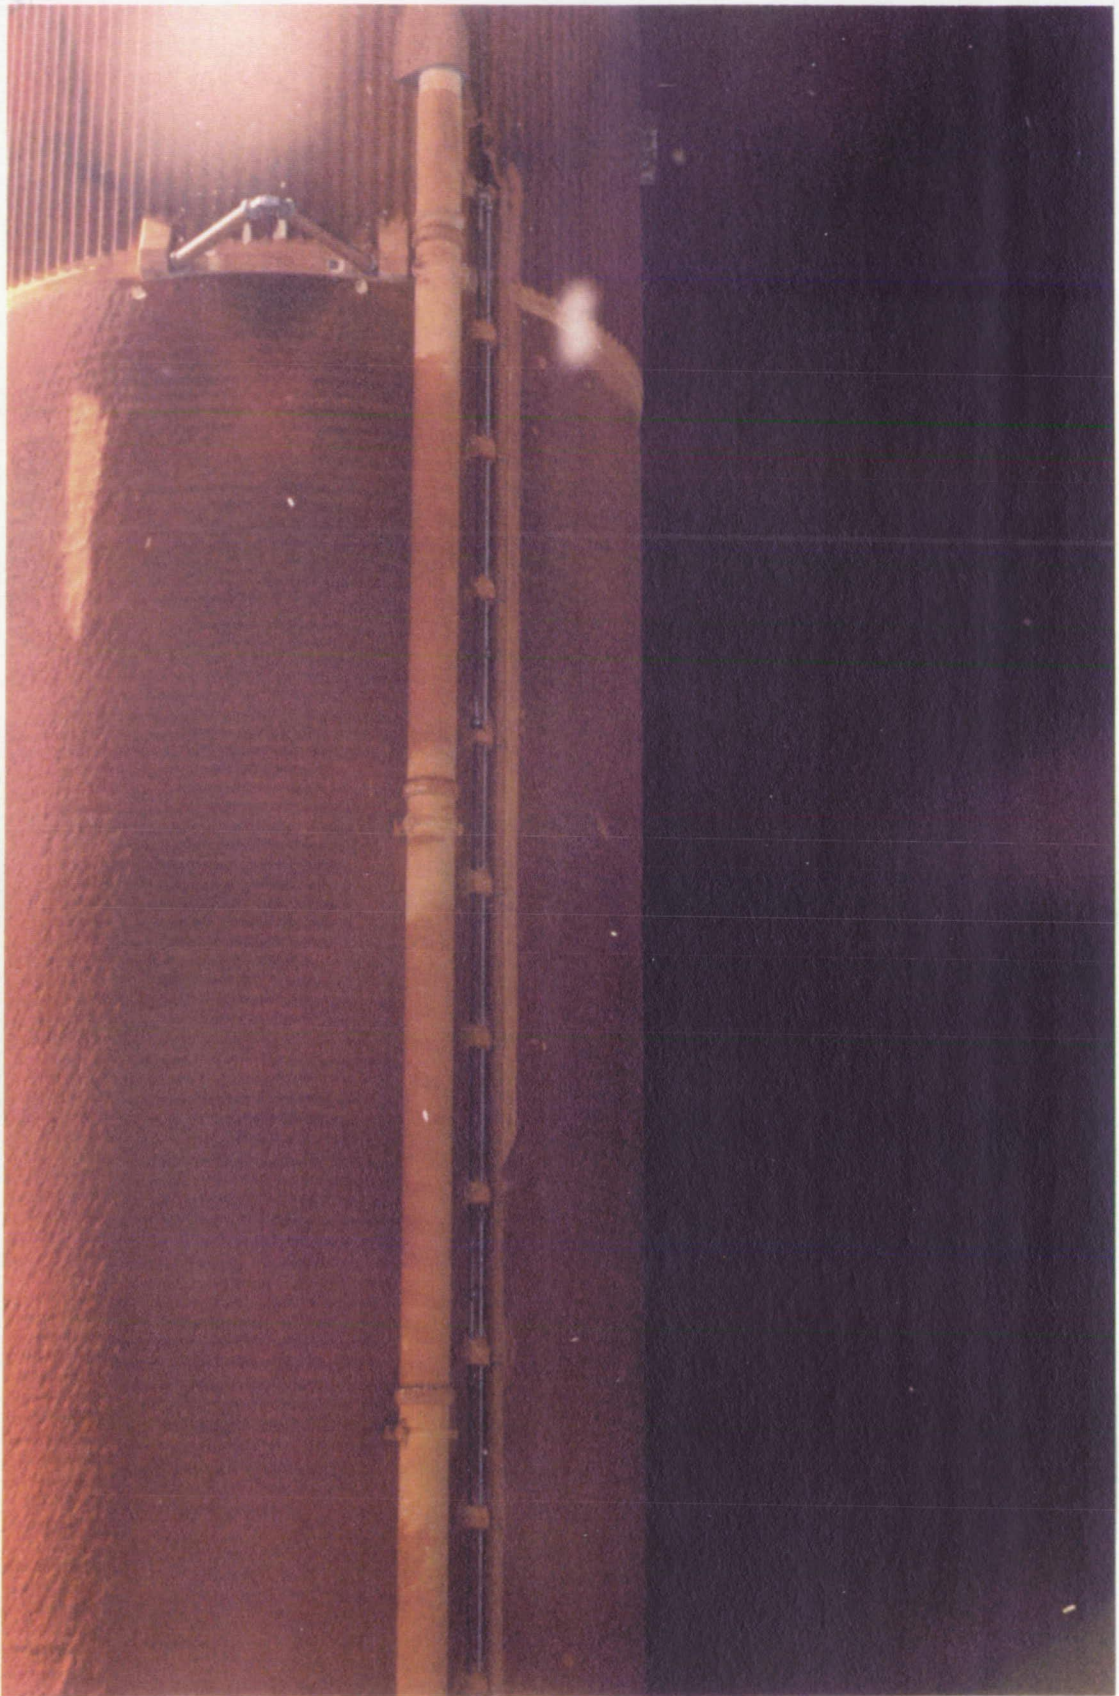
Loss of TPS on the +Z side of the ET near the Orbiter nose is a potential threat to lower surface tiles. Divots occurred on the intertank acreage, in the upper LH2 tank acreage, and in the LH2 tank-to-intertank flange closeout. The entire RH (+Y) bipod jack pad closeout was missing.

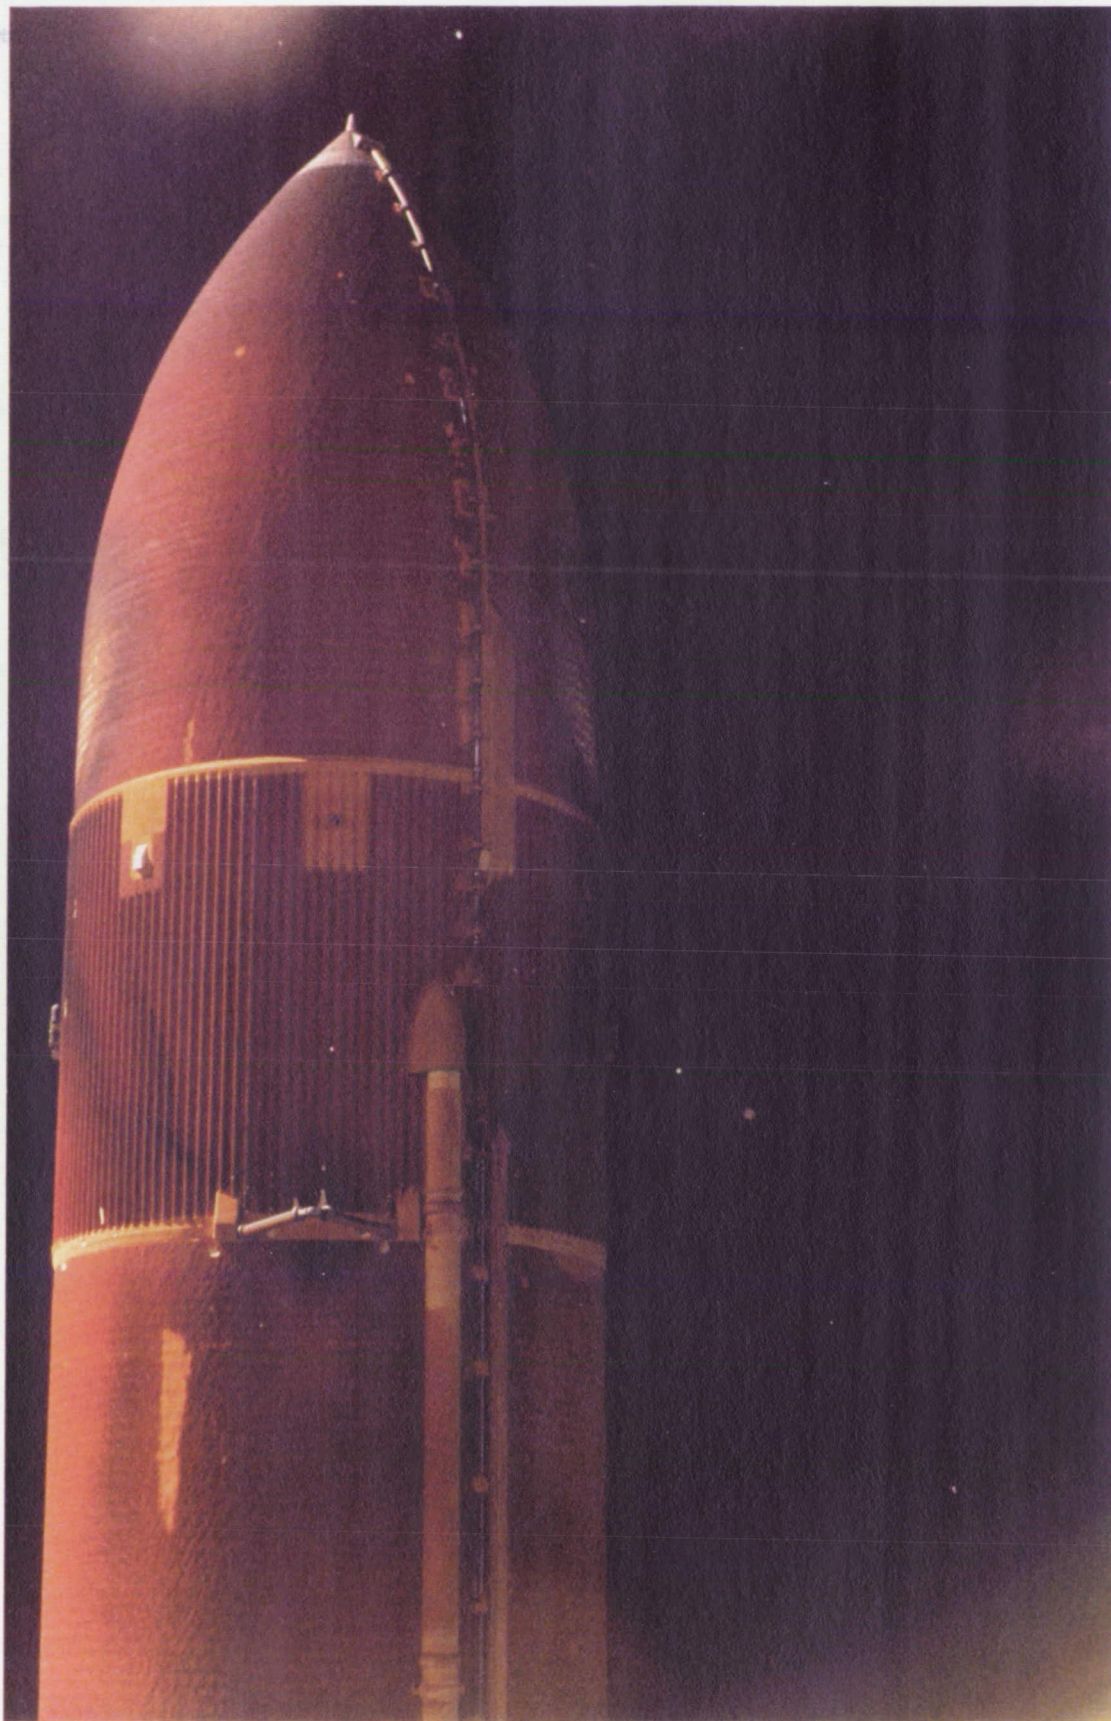
No anomalies were observed on the nosecone, LO2 tank acreage, PAL ramps, RSS antenna, or bipod ramps. PDL foam spill discoloration on the LH2 tank acreage below the left (-Y) bipod was present prior to launch.

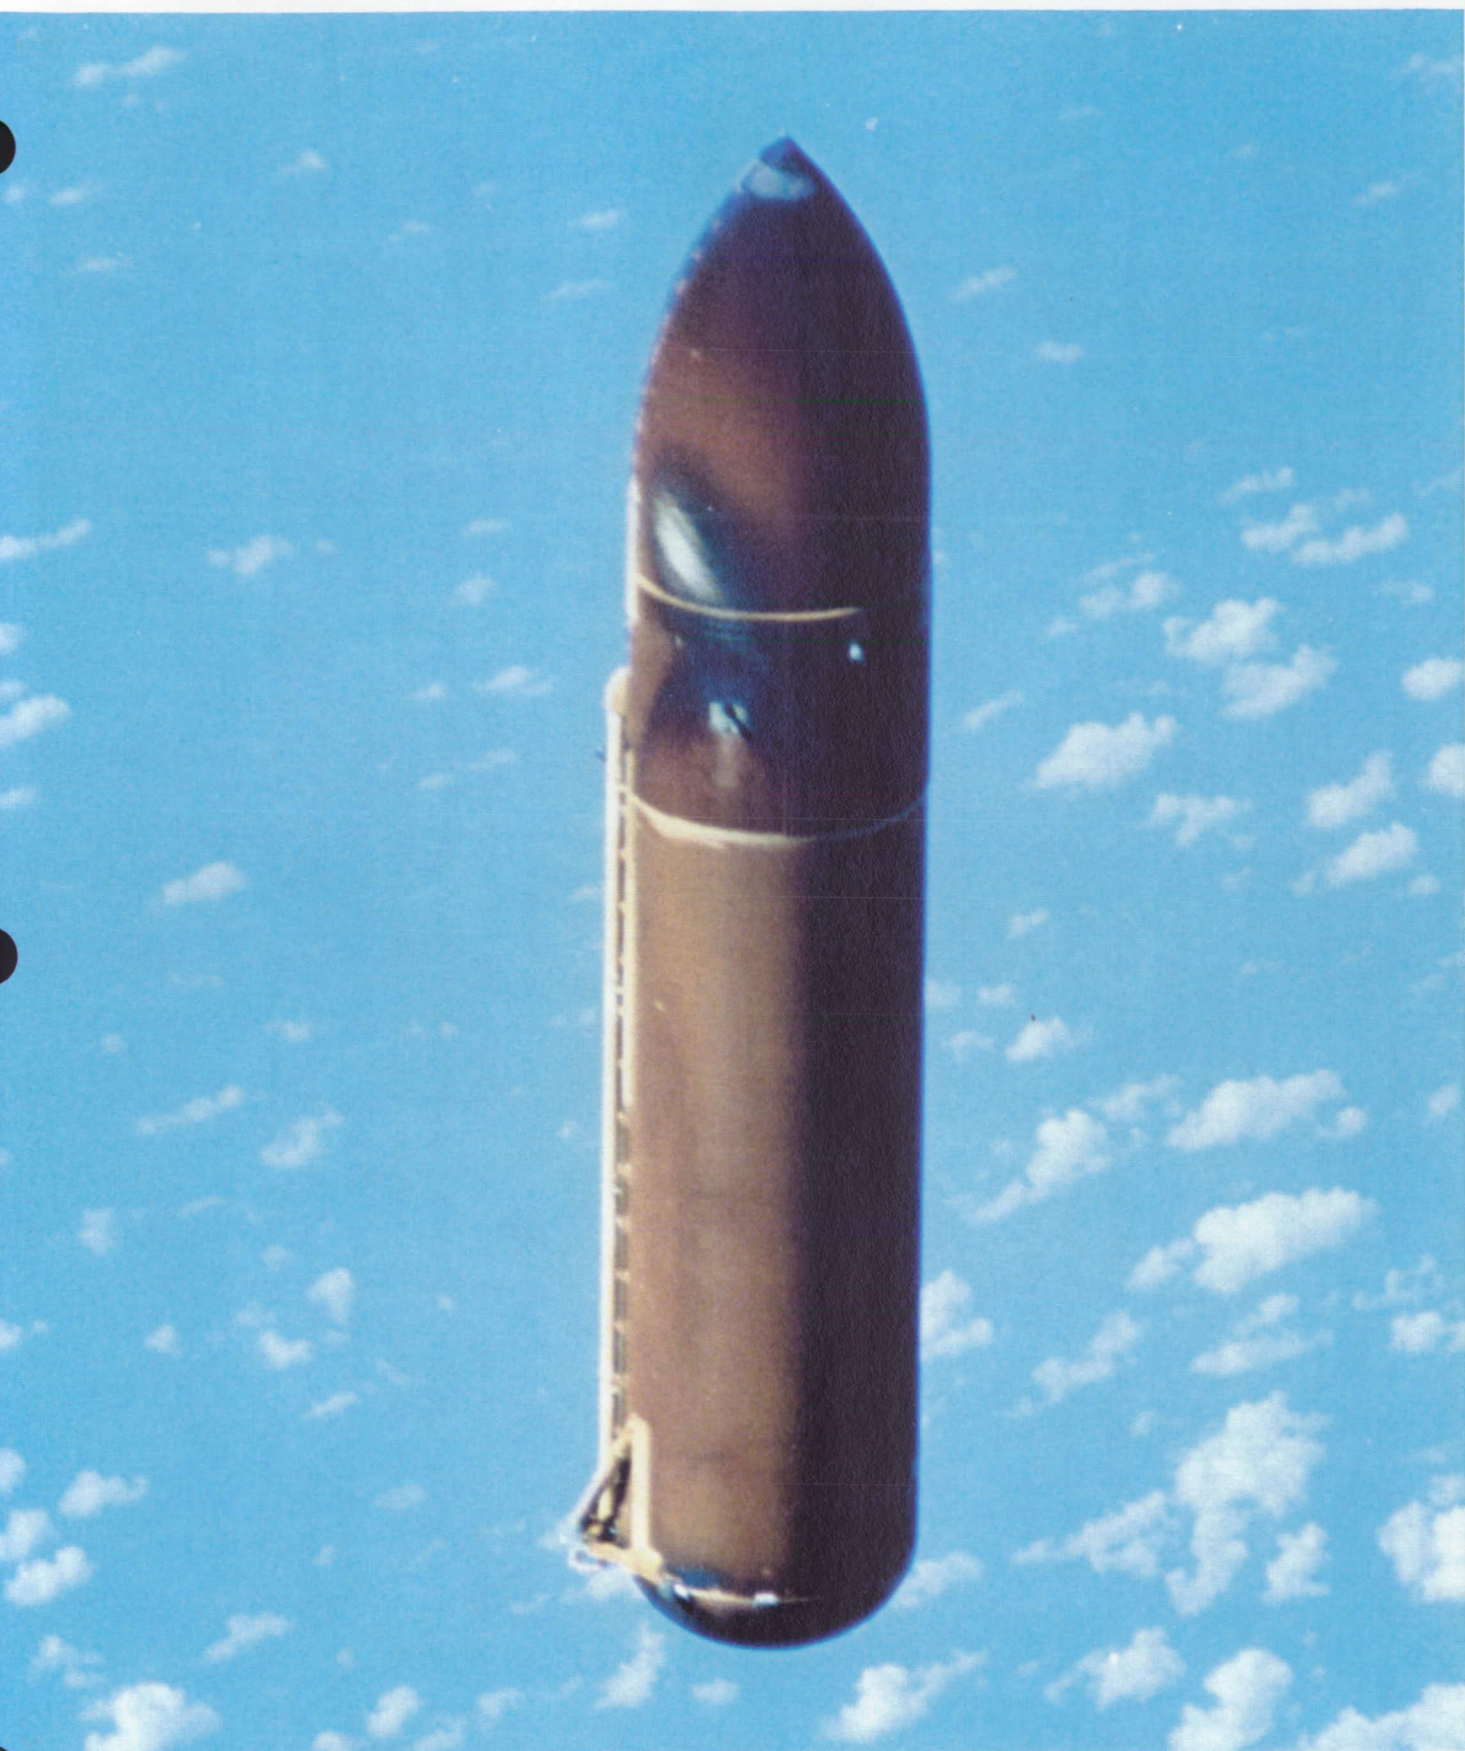
BSM burn scar on the LO2 tank was typical. No anomalies were observed on the +Y-Z side of the LO2 tank, intertank, LH2 tank, or aft hardpoint closeout.

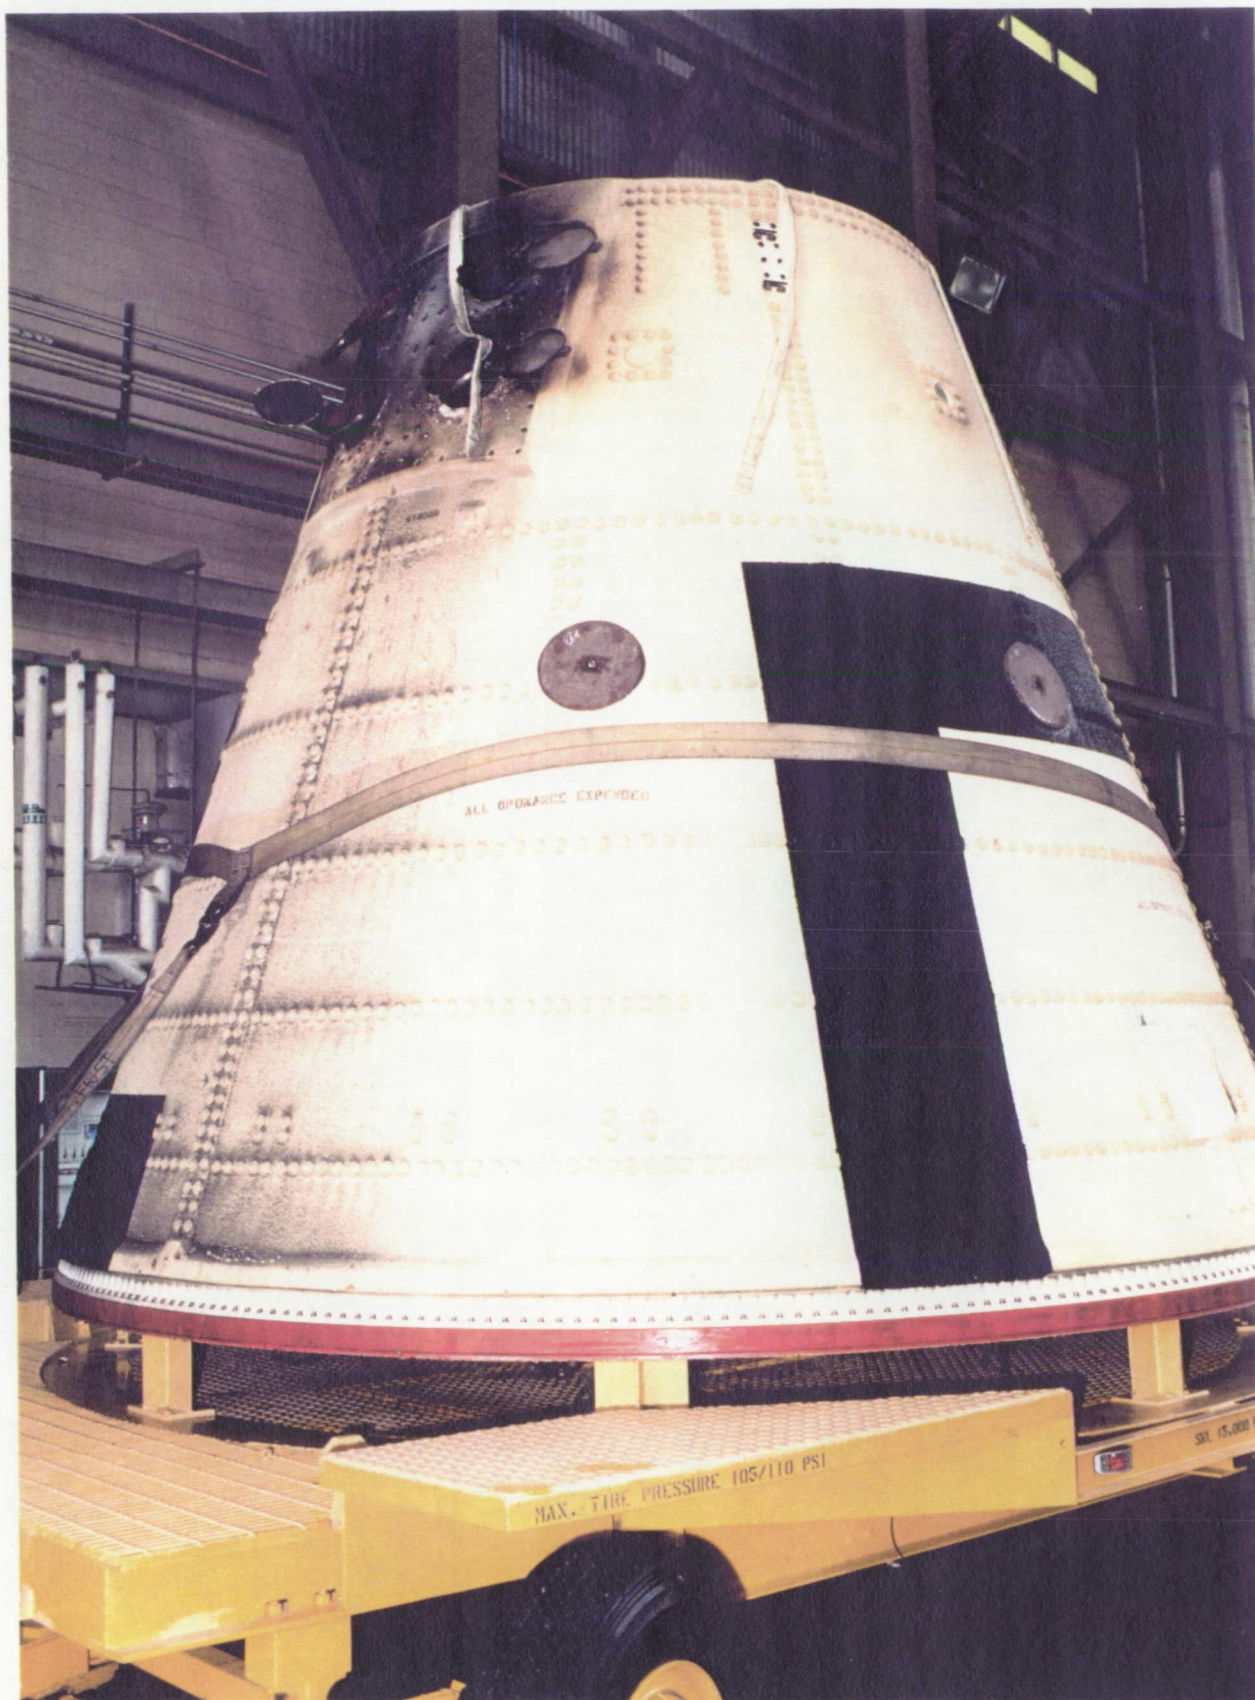
The RH frustum was missing no TPS, but had 31 MSA-2 debonds over fasteners. All BSM aero heat shield covers were locked in the fully opened position though the lower left cover attach ring had been bent by parachute riser entanglement.

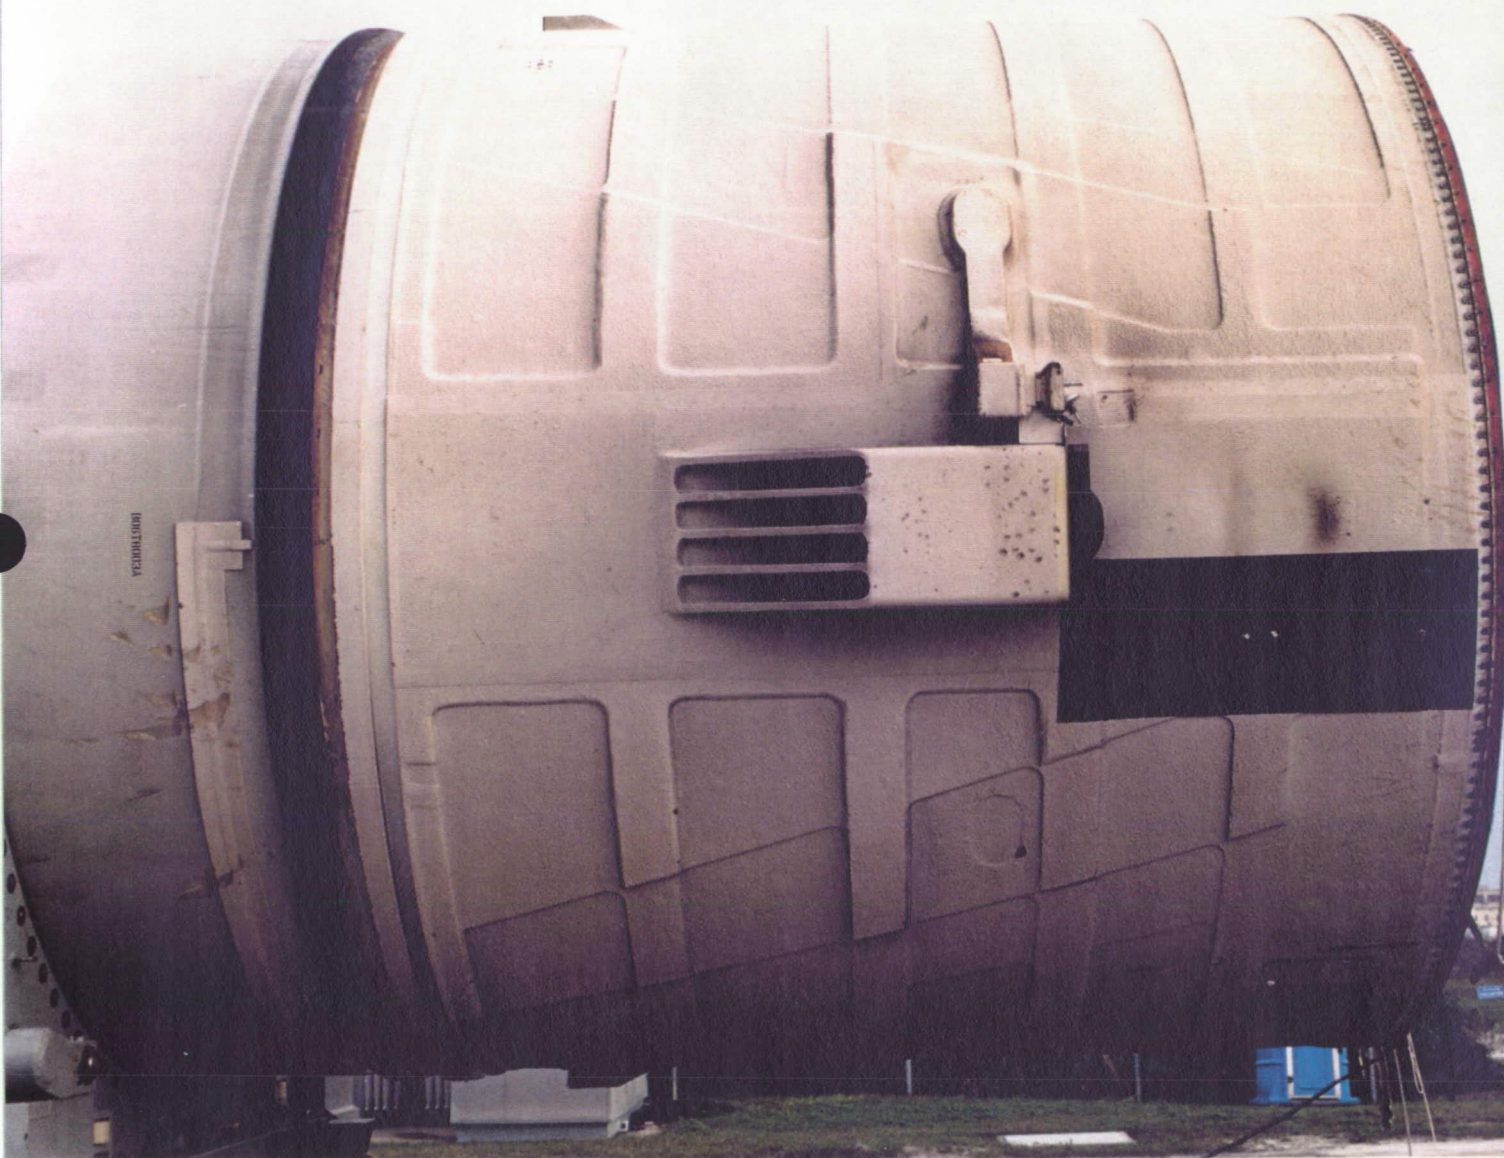
The RH forward skirt exhibited no debonds or missing TPS. Minor blistering of the Hypalon paint occurred on the forward ET/SRB attach point. Both RSS antenna covers/TPS were intact.

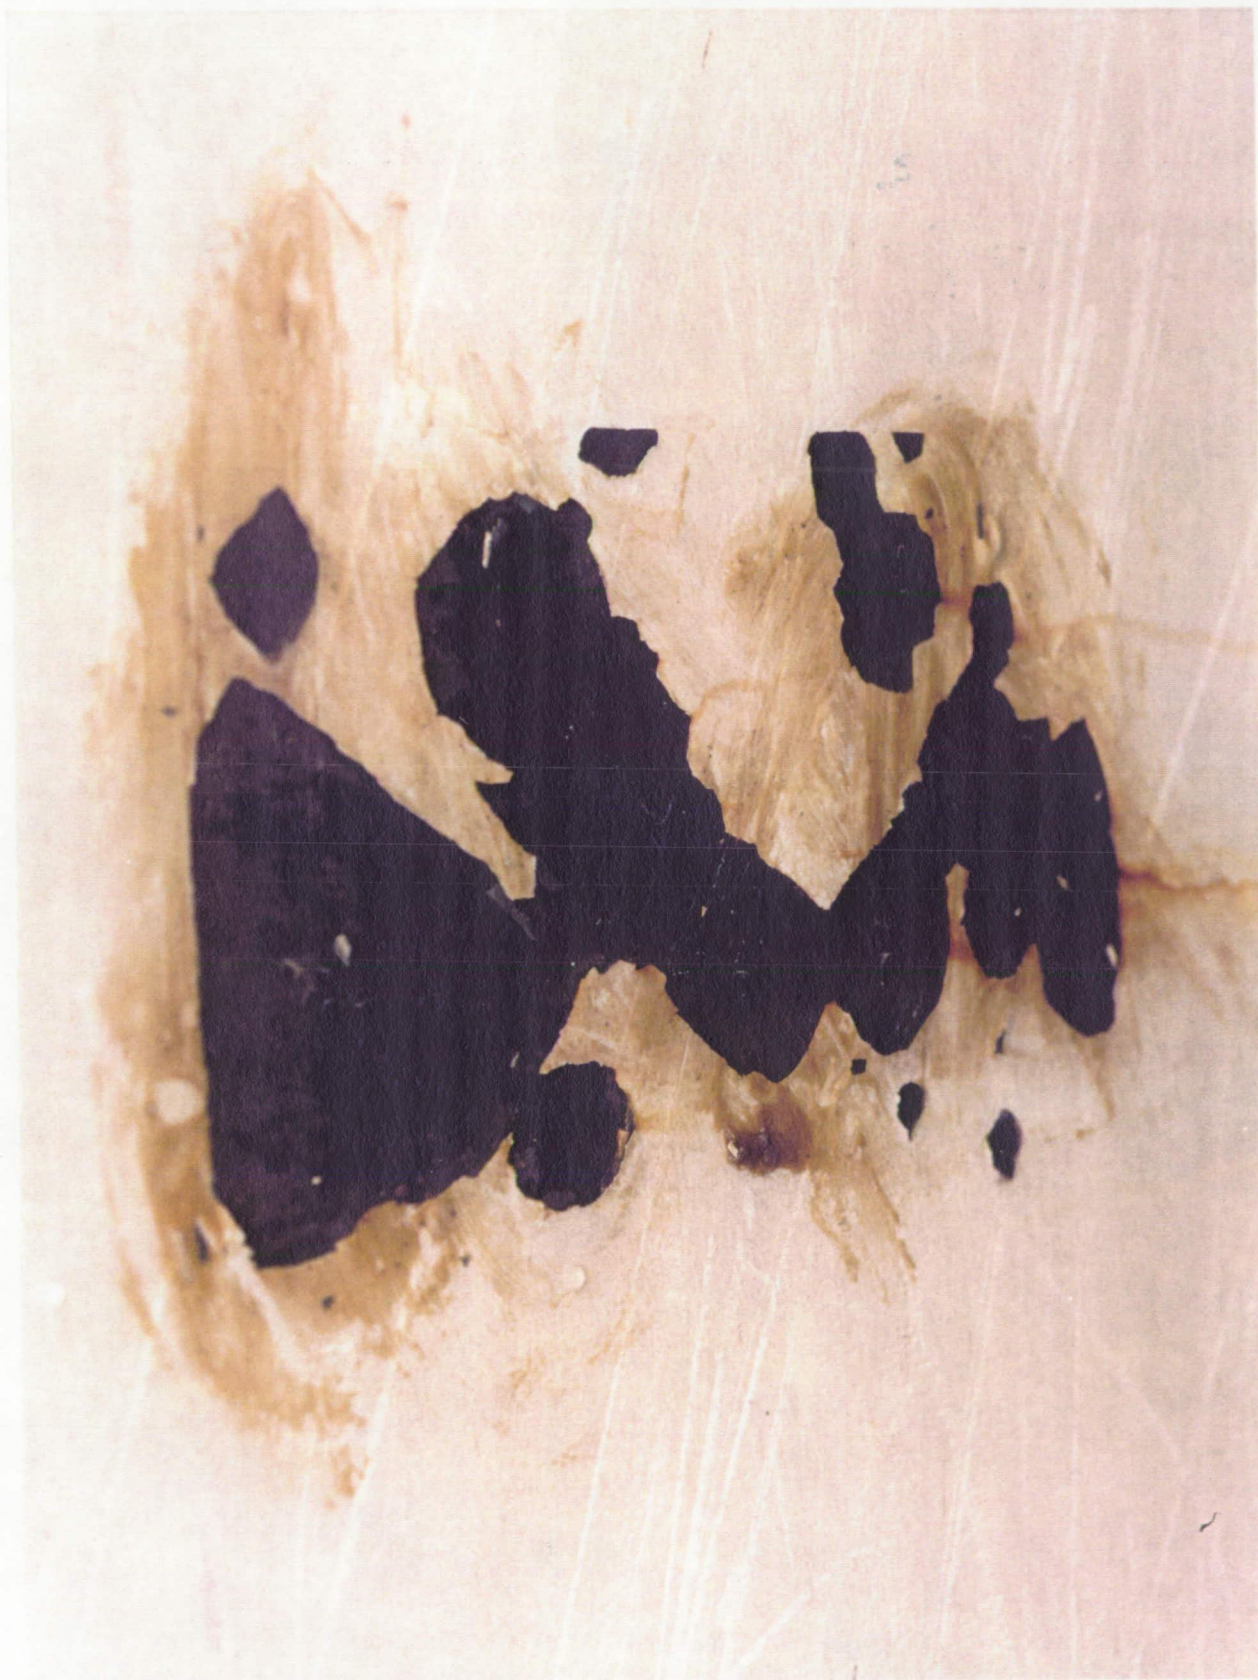
Several areas on the SRM segment cases exhibited missing paint and exposed metal substrate.

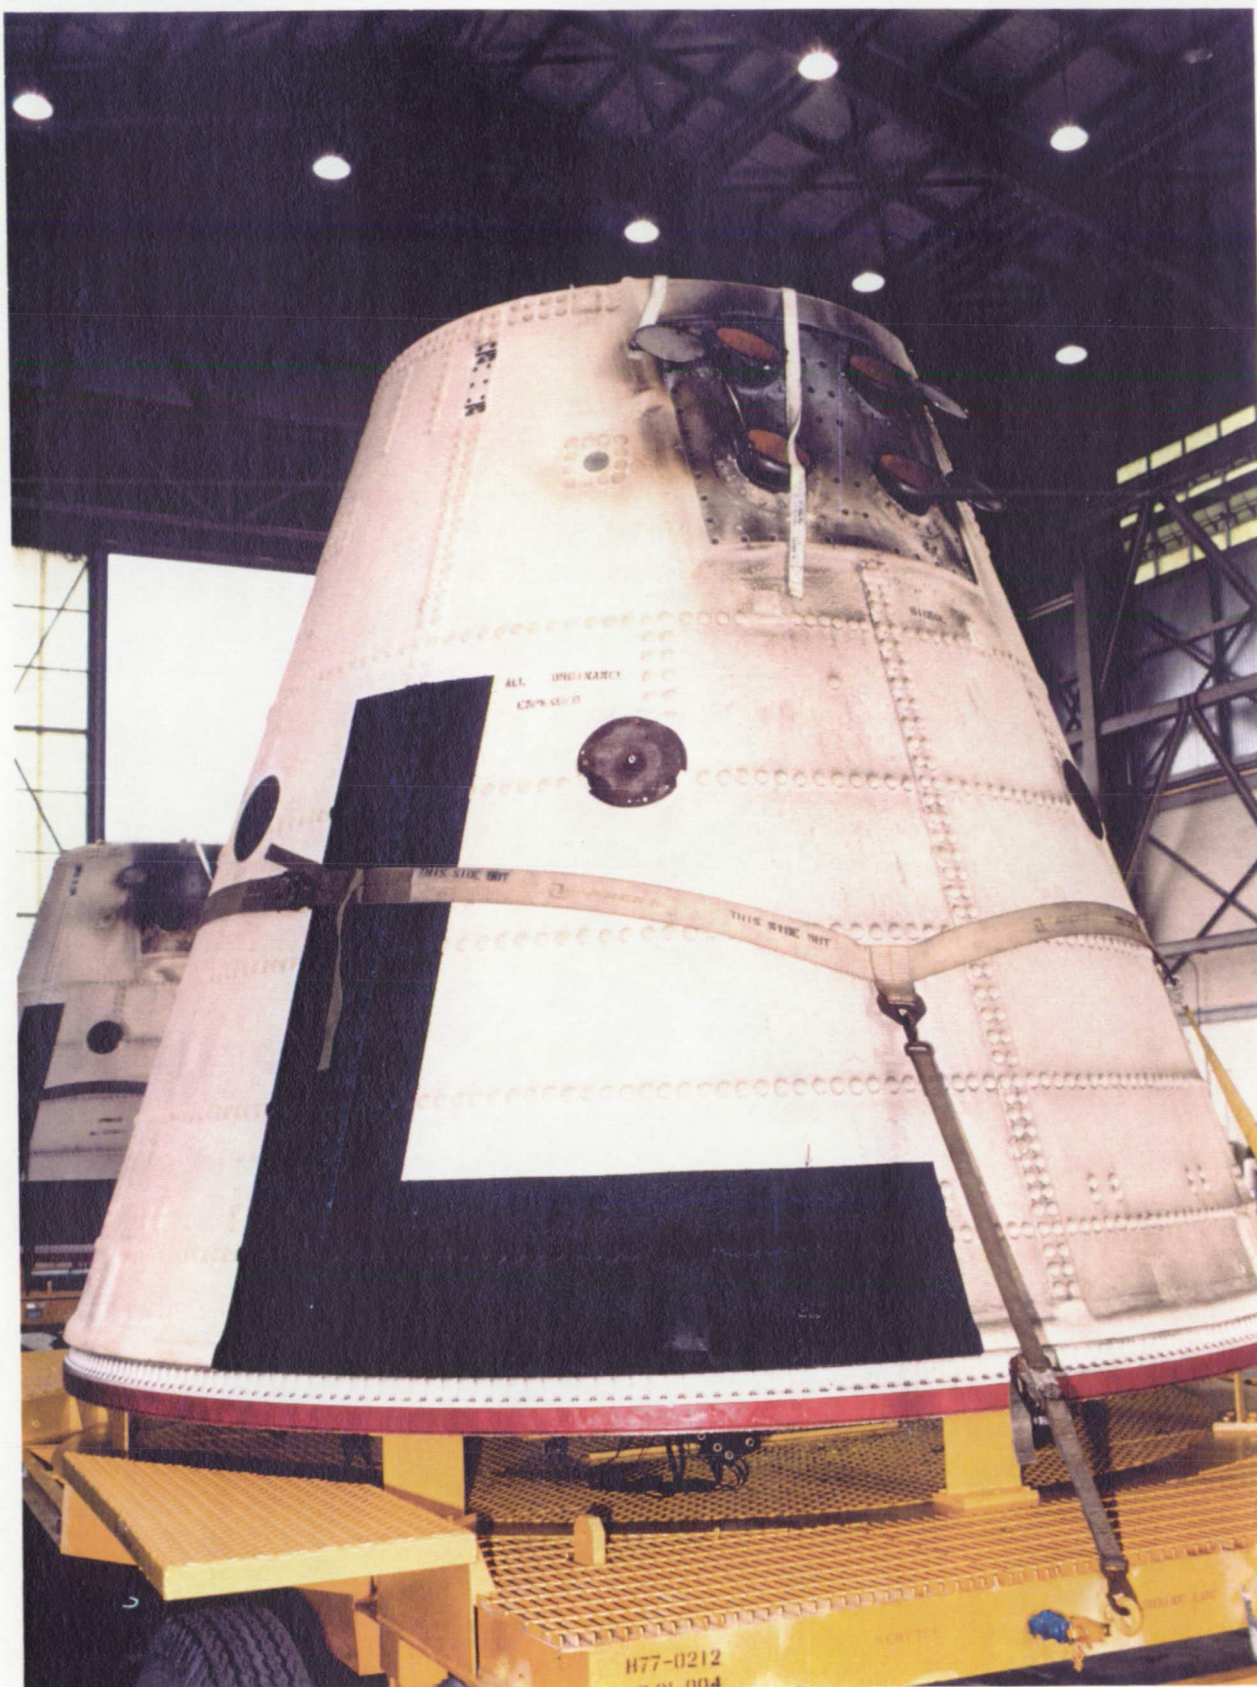
The LH frustum was missing no TPS, but had 18 MSA-2 debonds over fasteners. The BSM aero heat shield covers were locked in the fully opened position, though the lower left cover attach ring had been bent by parachute riser entanglement.

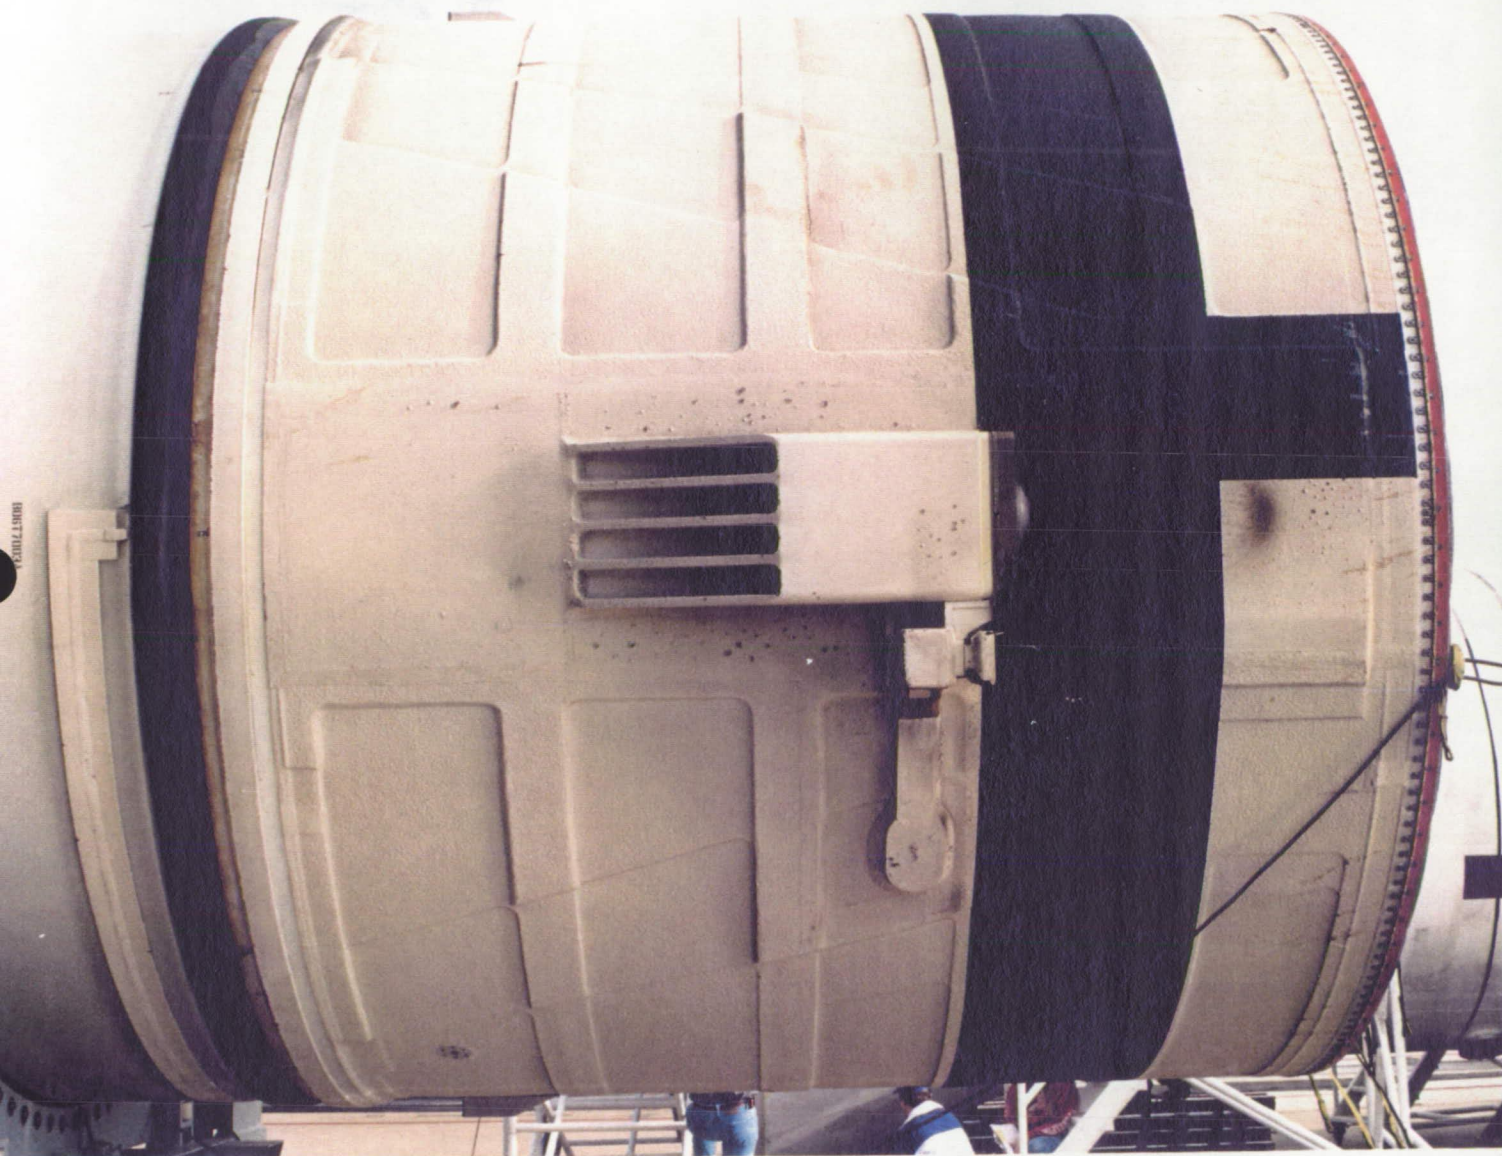
The LH forward skirt exhibited no debonds or missing TPS. The phenolic plates on both RSS antennae were intact. Minor blistering of the Hypalon paint occurred near the ET/SRB forward attach point.

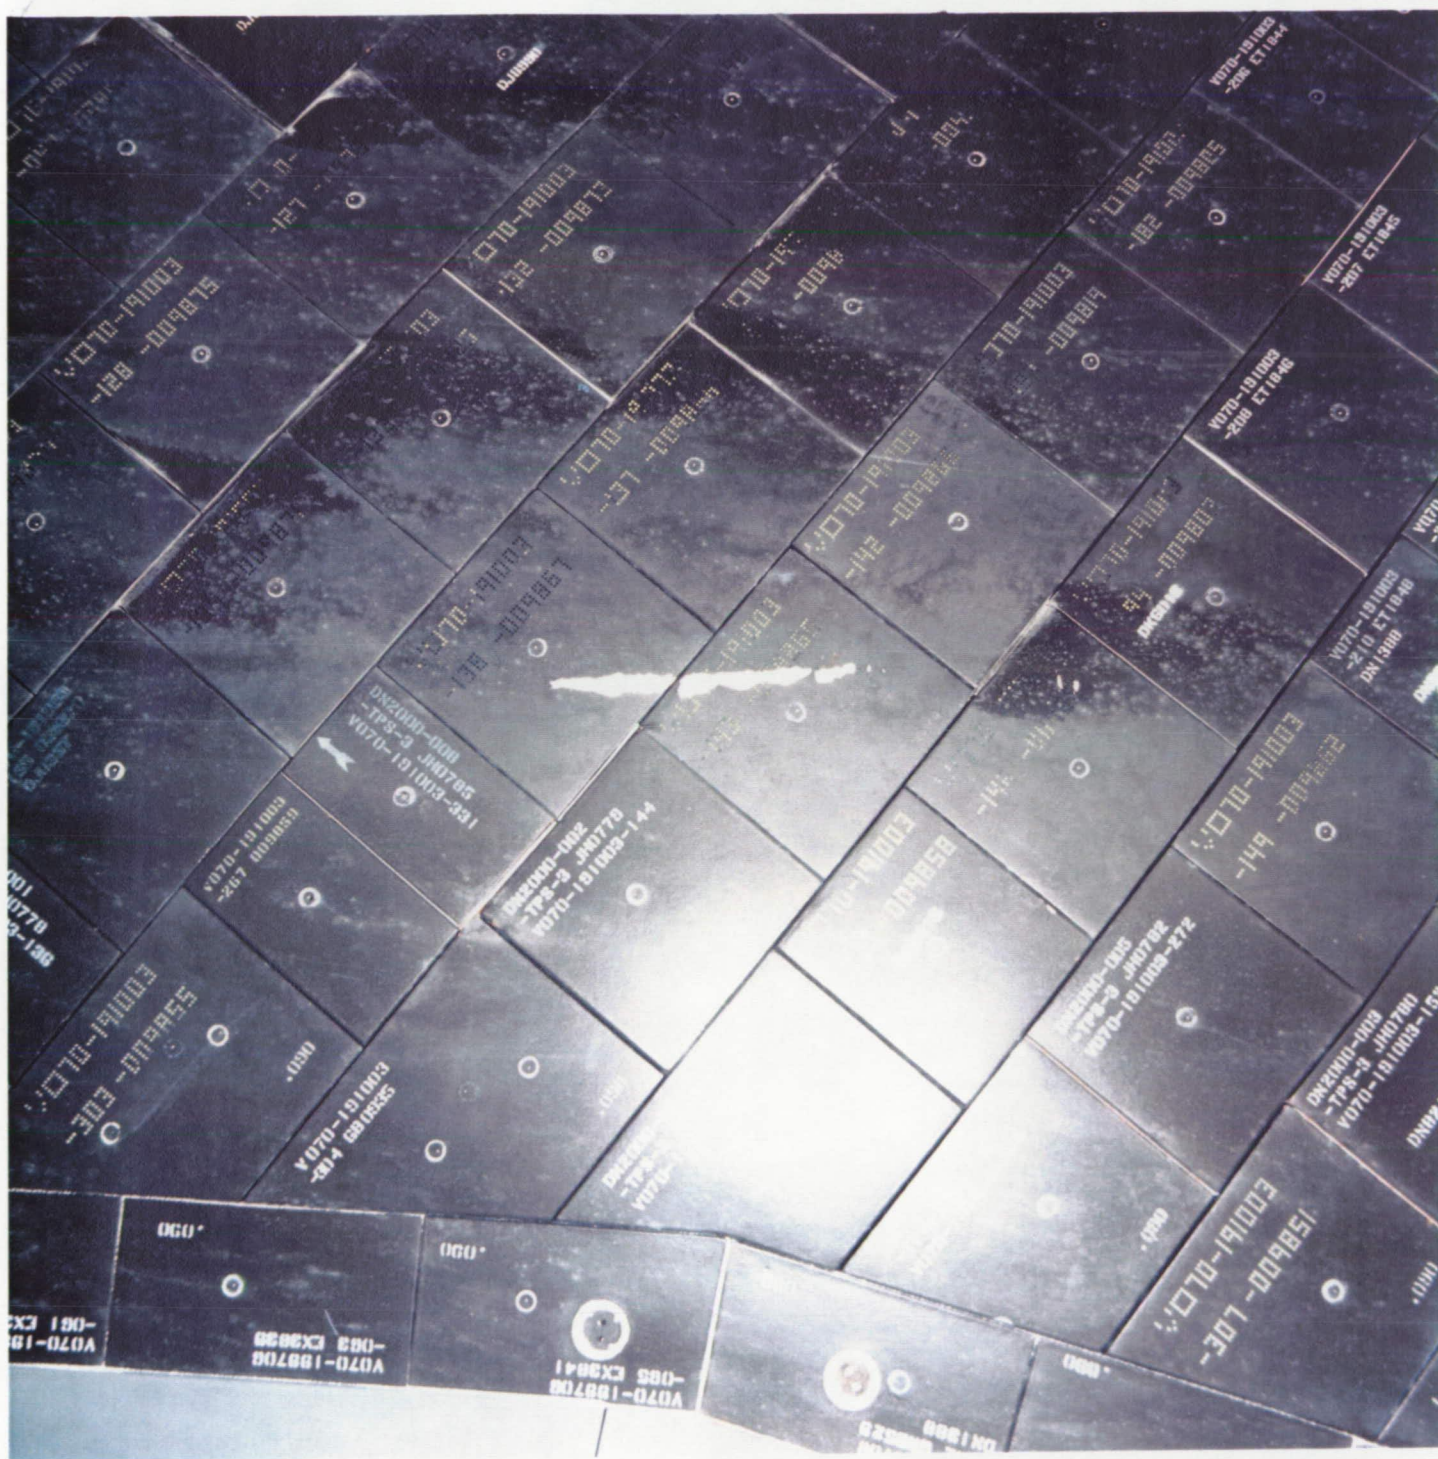
The Orbiter lower surface tiles sustained a total of 80 hits (less than average), of which 14 had a major dimension of 1-inch or greater (average).
